THE SOLAR CORRIDOR: THERMAL COMFORT IN THE SUNSPACE IN GERLINGER HALL

Janelle Black
Yasuyuki Yanagisawa
Summer Varde
Department of Architecture
1206 University of Oregon
Eugene, OR 97403-1206
jblack1@darkwing.uoregon.edu
yyanagis@darkwing.uoregon.edu

This case study looks at the temperature influxes within a south-facing corridor of Gerlinger Hall, a gymnasium for the University of Oregon in Eugene, Oregon. This space is a popular place for students, even when the temperature is out of the ASHRAE thermal comfort range.

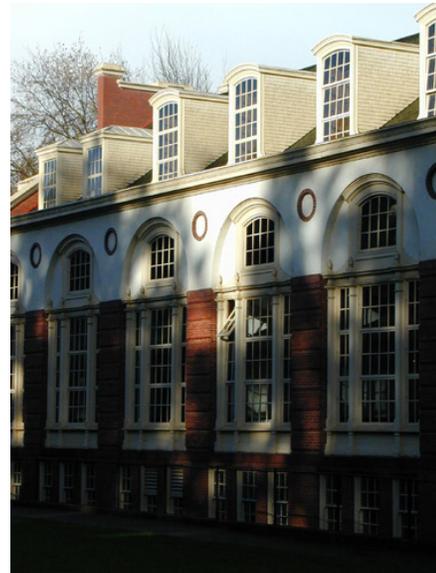
Fig.1: South exterior view of Gerlinger Hall

Gerlinger Hall was constructed in 1921 as a gymnasium at the University of Oregon, and is still used for this purpose today. The building is wood frame construction clad in masonry.

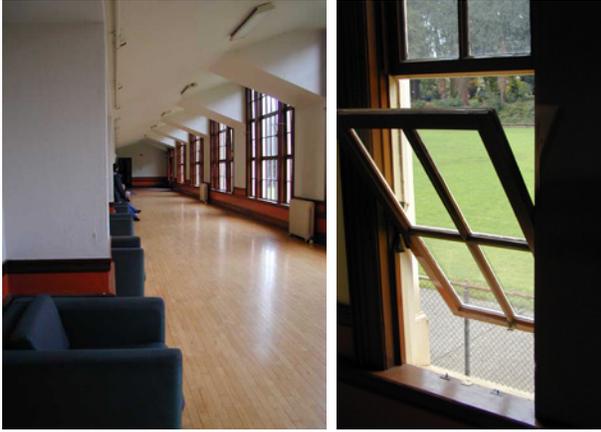
Fig. 2: South-facing corridor Fig. 3: Operable window

The windows are old, single-glazed and operable, with numerous gaps around the framing and opening mechanisms. Radiators along the window side run on steam heat and are individually controlled by a valve on each radiator. There is no thermostat associated with these radiators, but the valves are customarily set on one (out of five), and are left on at all times. The average surface temperature of the radiators (measured with a Raytek temperature gun) was determined to be 163°F.

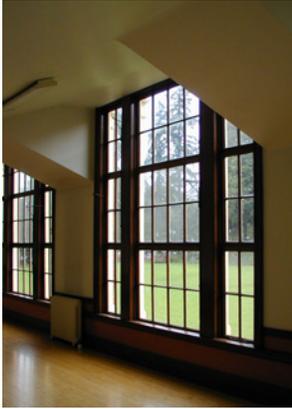
Fig. 9: Window bay

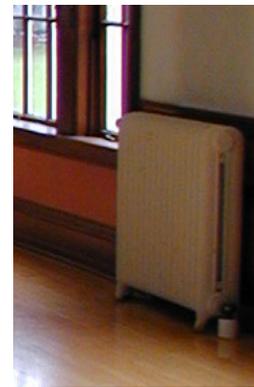
Fig. 16: Radiator
