LAPPING UP THE SUN: A VITAL SIGNS CASE STUDY OF WILLAMALANE AQUATIC CENTER (SPRINGFIELD, OR)

Joshua L. Brandt (jbrandt@darkwing.uoregon.edu)
Martha L. Breed (mbreed@darkwing.uoregon.edu)
Joshua D. Cohen (jcohen2@darkwing.uoregon.edu)
Department of Architecture
1206 University of Oregon
Eugene, OR 97403

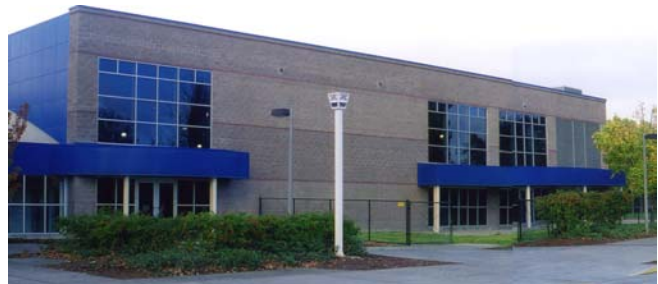
Fig. 1: East Wall of Aquatic Center

The East wall contains two large areas of glazing, which have minimal sun-shading. There is also a strip of glazing located high on the South wall, above the locker room building volume. Kalwall is installed horizontally above the spa pool. Kalwall on the West wall also provides some daylight. Willamalane has three pools: a lap pool, a diving pool, and an exercise pool, as well as a hot tub located at the South edge of the space. The target temperatures for the water in these pools are:

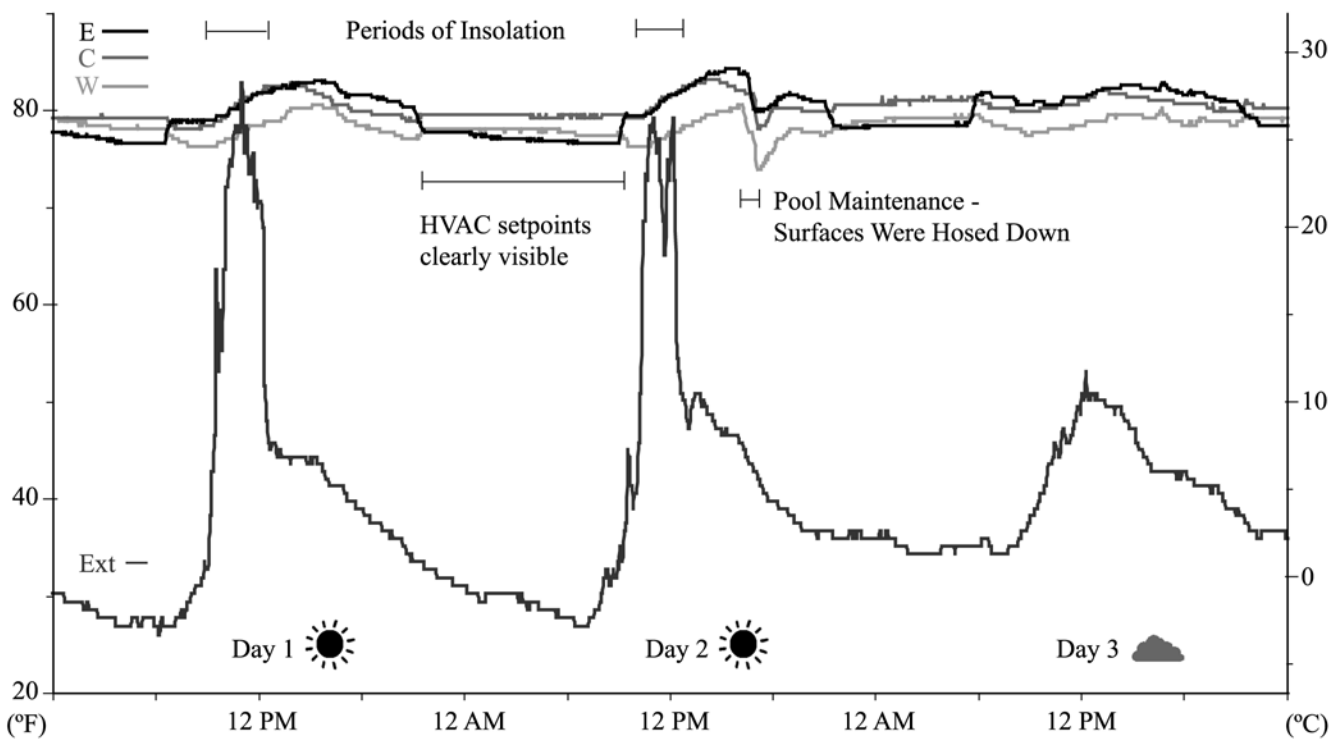
Fig. 3: Series 1 Data

Temperature readings collected at Willamalane Aquatic Center are presented in Figures 3 and 4. The data reveals a number of factors affecting the indoor air temperature. The strongest of these are:

The effect of direct sunlight is apparent on both charts, particularly Series 1, when comparing Day 1 (a clear day) with Day 3 (mostly cloudy). The large temperature spike denotes the time period that the outdoor HOB0 (located on the east side of the building) received full sunlight. Local weather records indicate that the sky remained clear all day, allowing sun to enter the natatorium through south- and west-facing clerestory windows. This correlates well with the gradual increase in indoor air temperature observed for Day 1. In contrast, when clouds move in on Day 3, a more constant daytime temperature profile results from a lack of direct sunlight.

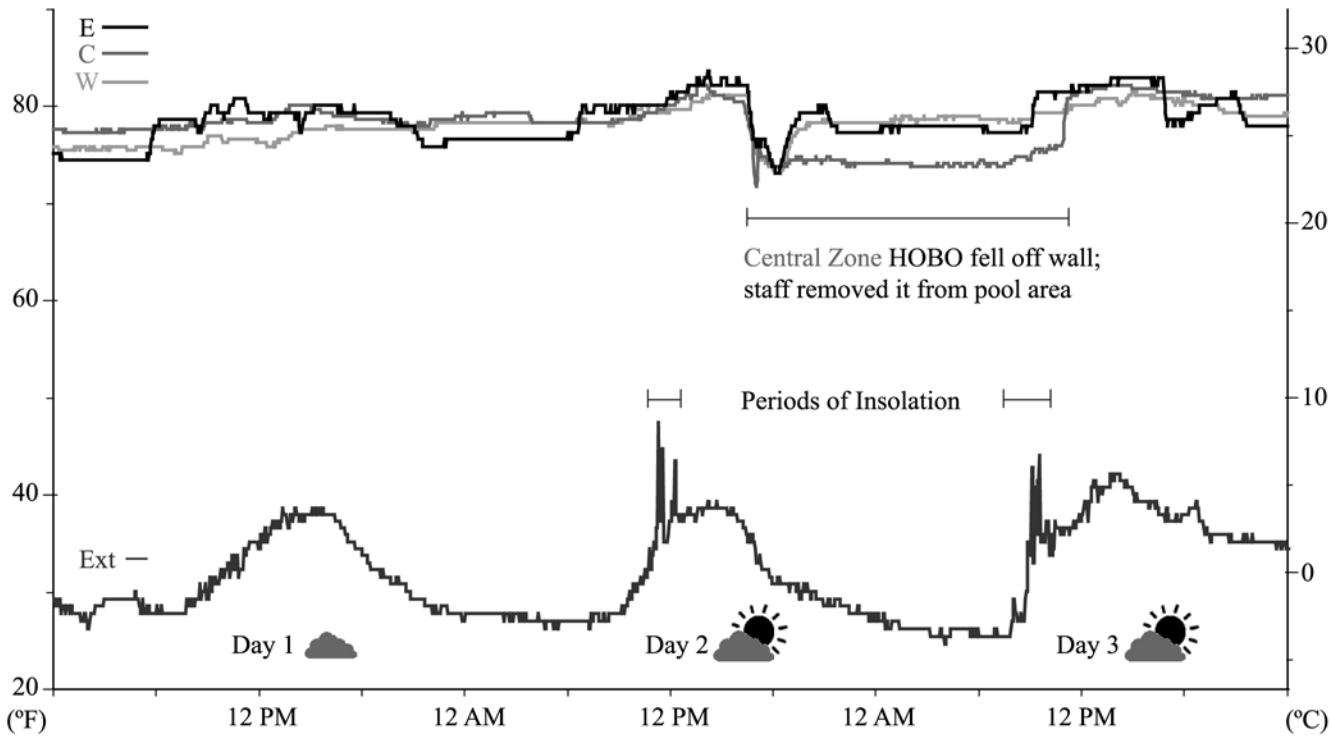
Fig. 4: Series 2 Data

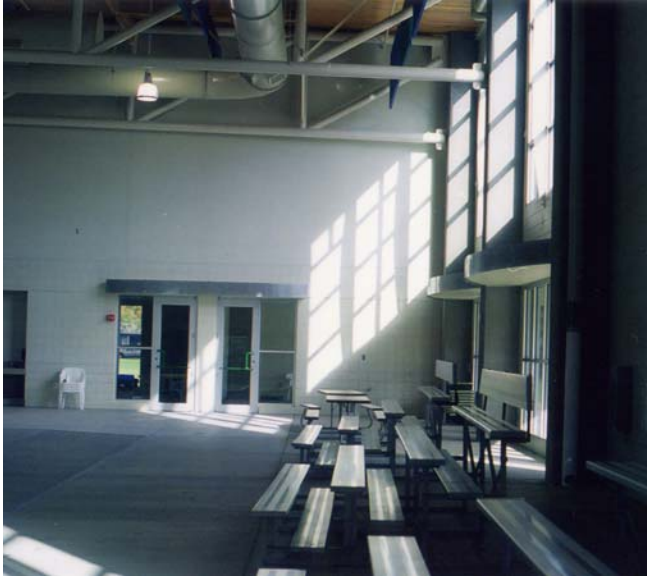
Fig. 5: Insolation

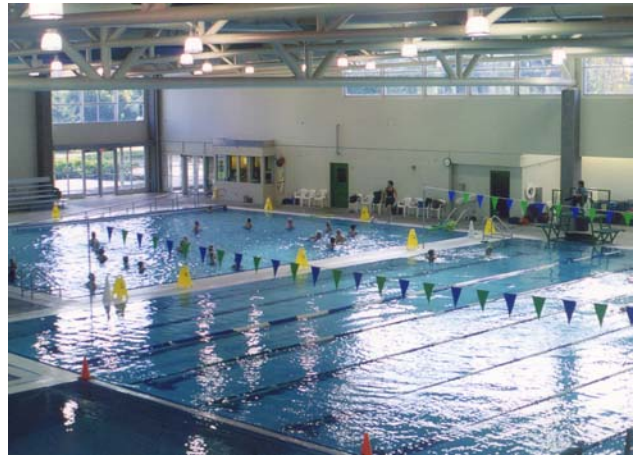
Fig. 8: Sun on the pool surfaces
